**Spur gear test rig for testing of AE-sensors with tribo contacts.**

### A SENSOR CONCEPT FOR THE MONITORING OF TRIBOCONTACTS IN GEAR FLANKS

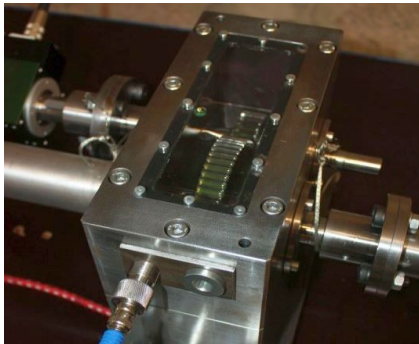
A single-stage spur gear stage was used as the test system for the vibration tests. The two gears are fixed rolling contact bearings. The gear stage is driven by an electric motor and the load is simulated by an electric motor used as a motor brake. This allows the speed and torque in the gear mesh to be varied independently of each other. Oils of different viscosities and mechanical damage to individual tooth flank surfaces of the drive gear was prepared were used to simulate the real meshing situation(see left).

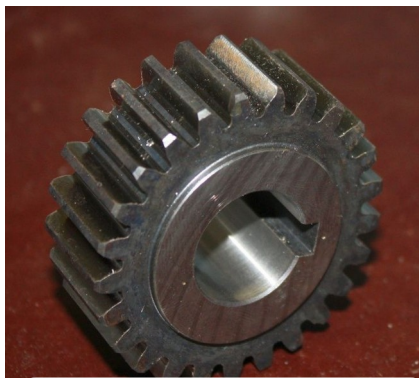
**View of the prepared gear flank (brown "12 o'clock")**

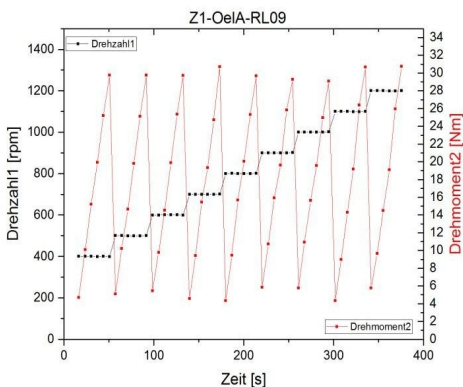
**Load diagram: Determining the torques as a function of the speed.**

The vibration spectra (0 - 500 kHz) were recorded for both sensors as a function of the speed-torque characteristics. This revealed striking differences in individual resonances, which were analysed using a modal analysis for the stationary and rotating coordinate system (see below and next page).

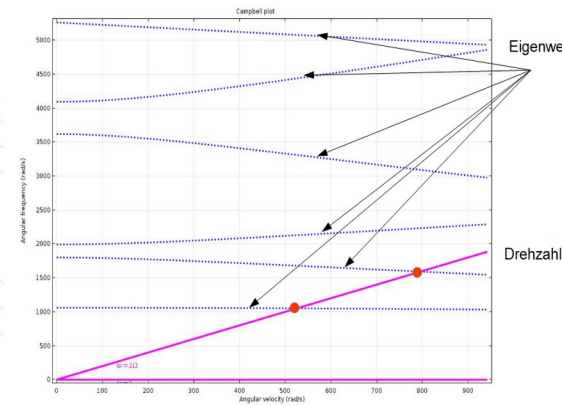
Relationship between speeds and resonances (eigenvalues).

Depending on the stationary and rotating coordinate system, the striking differences in the detectable structural resonances can be explained as a function of the rotational speed. The resonances result from the speed-dependent excitation as eigenmodes of the vibrating gear-shaft ensemble.

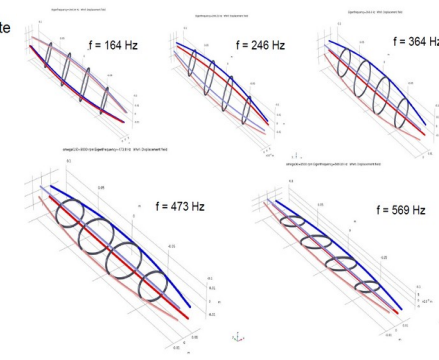
Calculation of the "whirl modes" in the fixed coordinate system (housing)
